SOUTHERN AREA GROUNDWATER INTERCEPTOR TRENCH CONSTRUCTION & INSTALLATION REPORT

DETREX RD/RA
SOURCE CONTROL AREA
DETREX FACILITY
ASHTABULA, OHIO
DOCKET NO. V-W-98-C-450

Detrex Corporation
Ashtabula, OH

January 2008

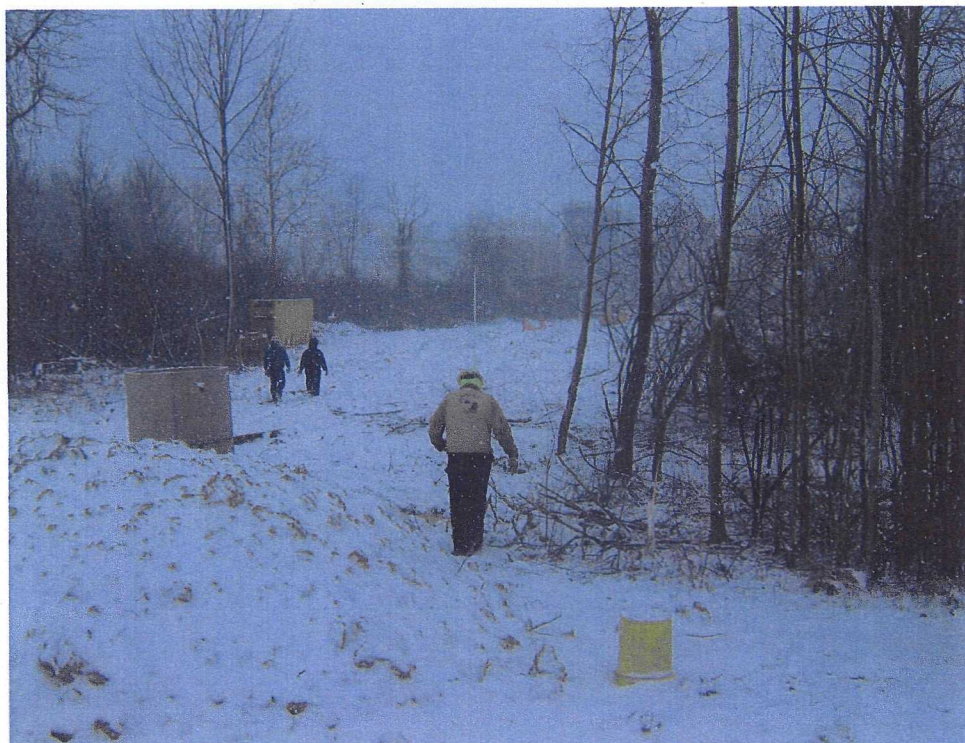
PHOTOGRAPH 1: East of GWIT Sump #2, during GWIT pipe installation (See orange safety fence).

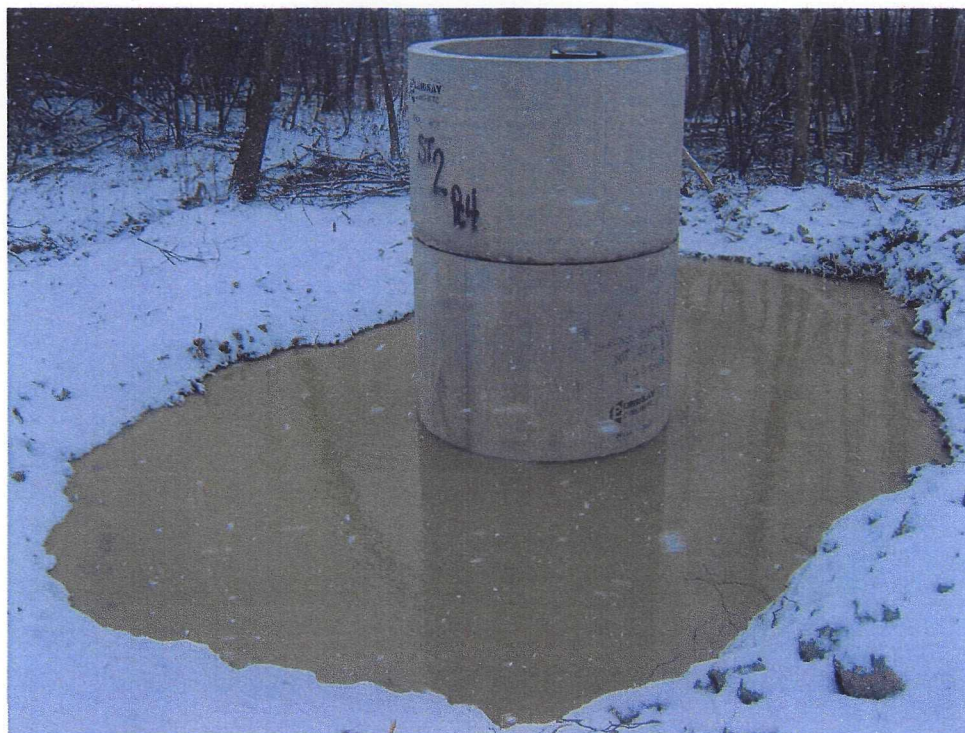
PHOTOGRAPH 2: GWIT Sump #2 excavation filled with water (before water was pumped).

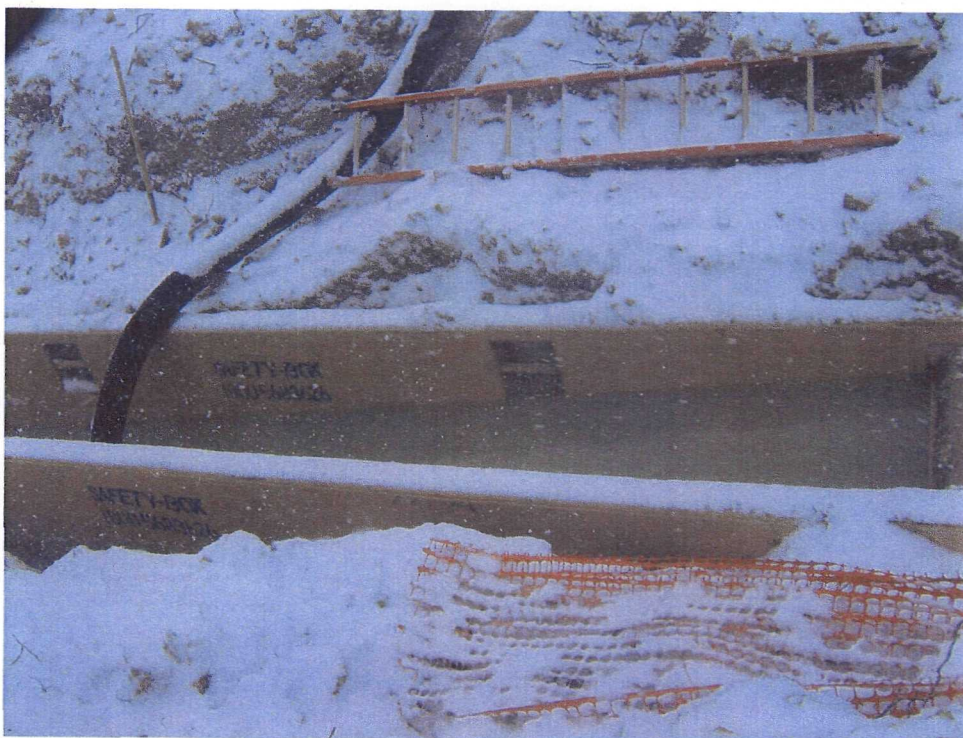
PHOTOGRAPH 4: GWIT collection trench east of GWIT Sump #2, trench box filled with water (before water was pumped from GWIT Sump #2).

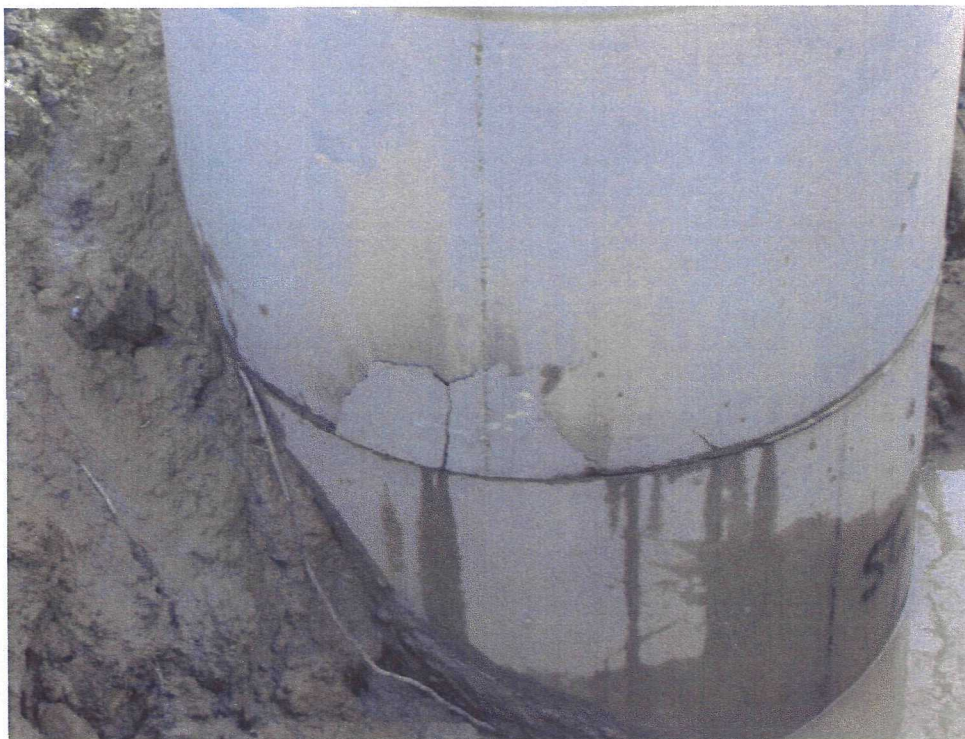
PHOTOGRAPH 5: GWIT Sump #2 showing exterior cracking to the third riser section.

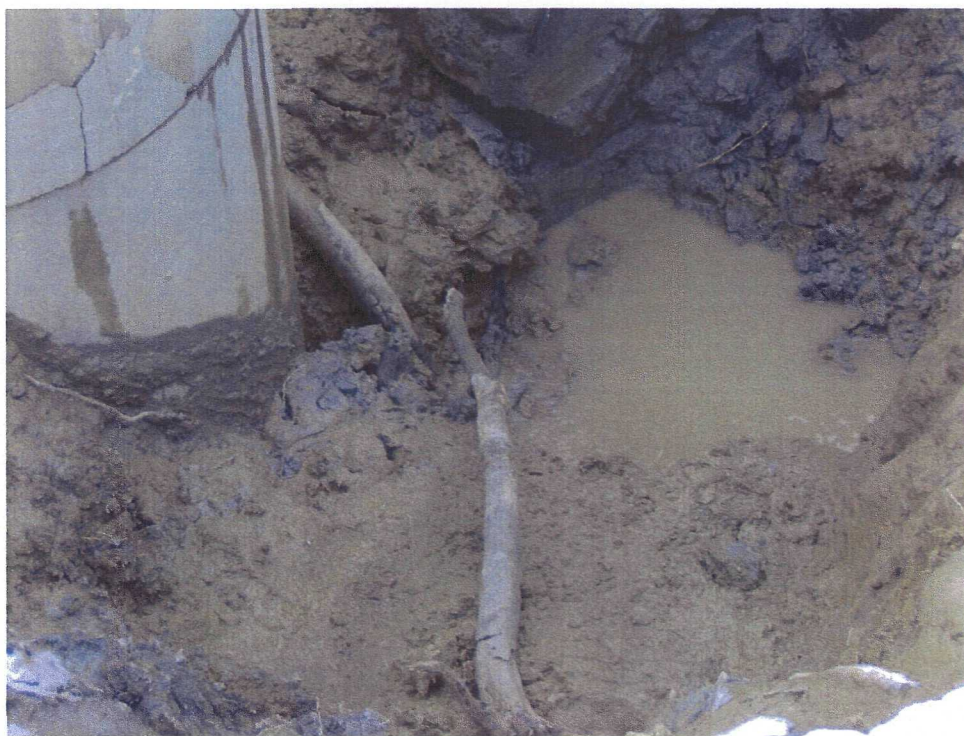
PHOTOGRAPH 6: GWIT Sump #2 showing exterior cracking to the third riser section and the surrounding area following water pumping.

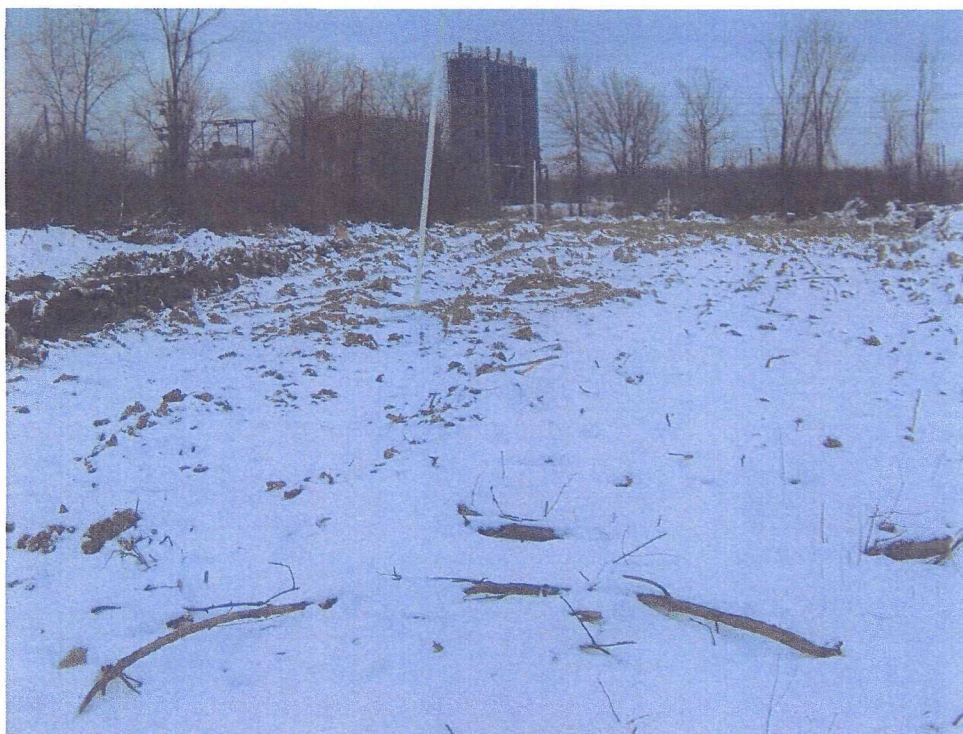
PHOTOGRAPH 8: Sample well located approximately 100' east of GWIT Sump #2.

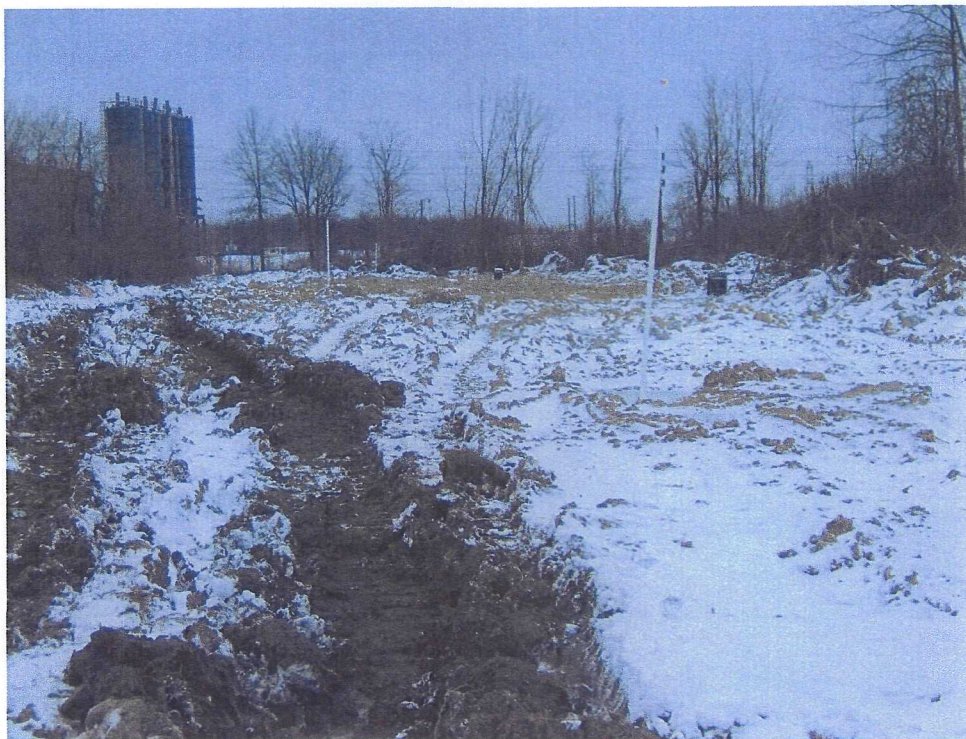
PHOTOGRAPH 9: Completed installation of the GWIT collection system east of GWIT Sump #2. GWIT pipe location is identified by the three sample wells spaced approximately 100' apart.

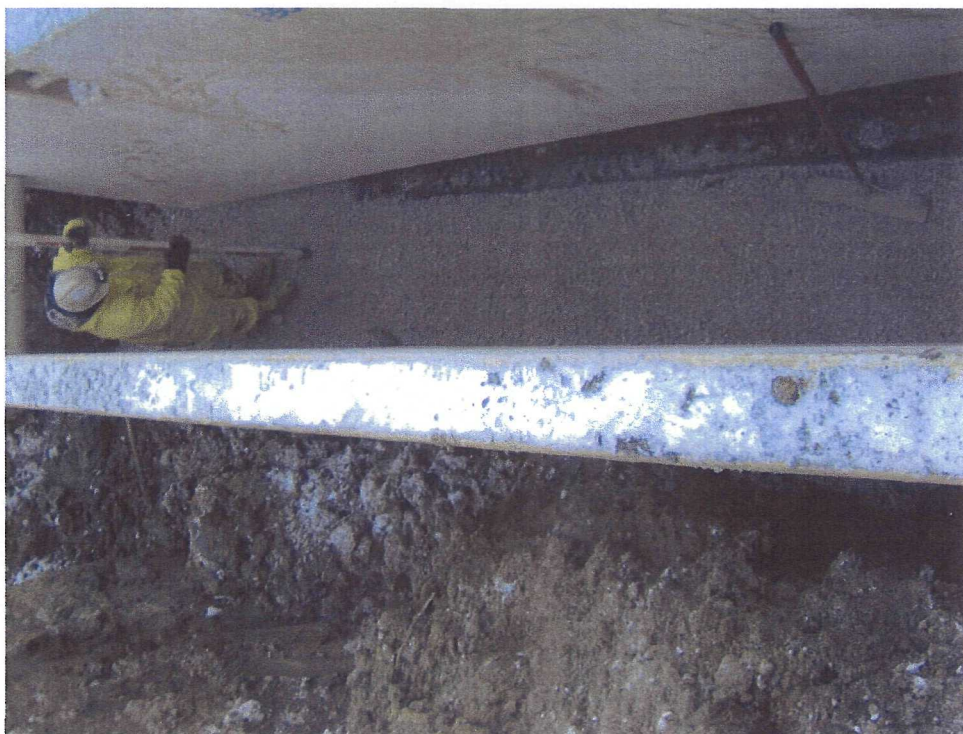
PHOTOGRAPH 10: West of GWIT Sump #2, SunPro employee inside trench box grading gravel before laying GWIT collection pipe.

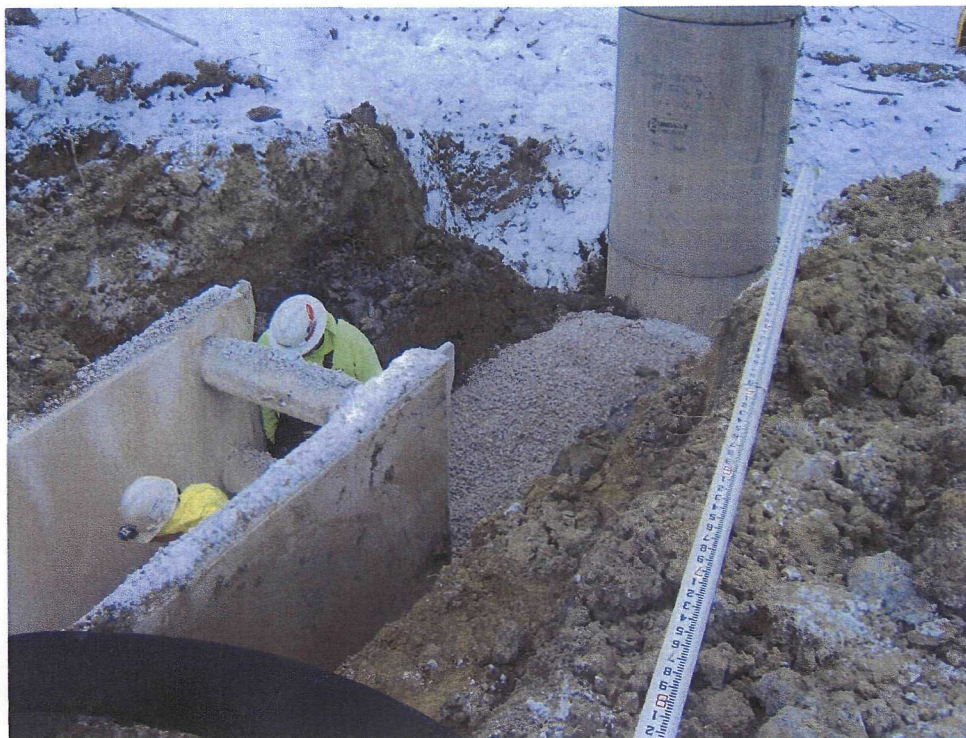
PHOTOGRAPH 11: West of GWIT Sump #2. Trench is excavated, GWIT pipe installed, trench is backfilled with gravel and trench box is moved.

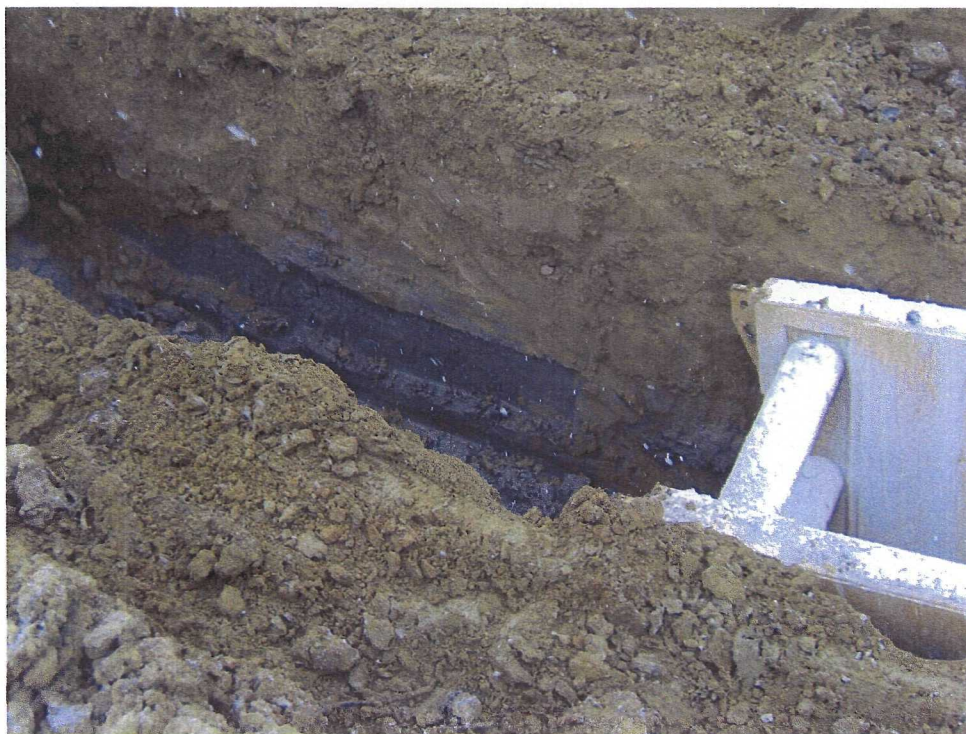
PHOTOGRAPH 12: West of GWIT Sump #2, Gray glacial till layer is visible where GWIT pipe is being placed.

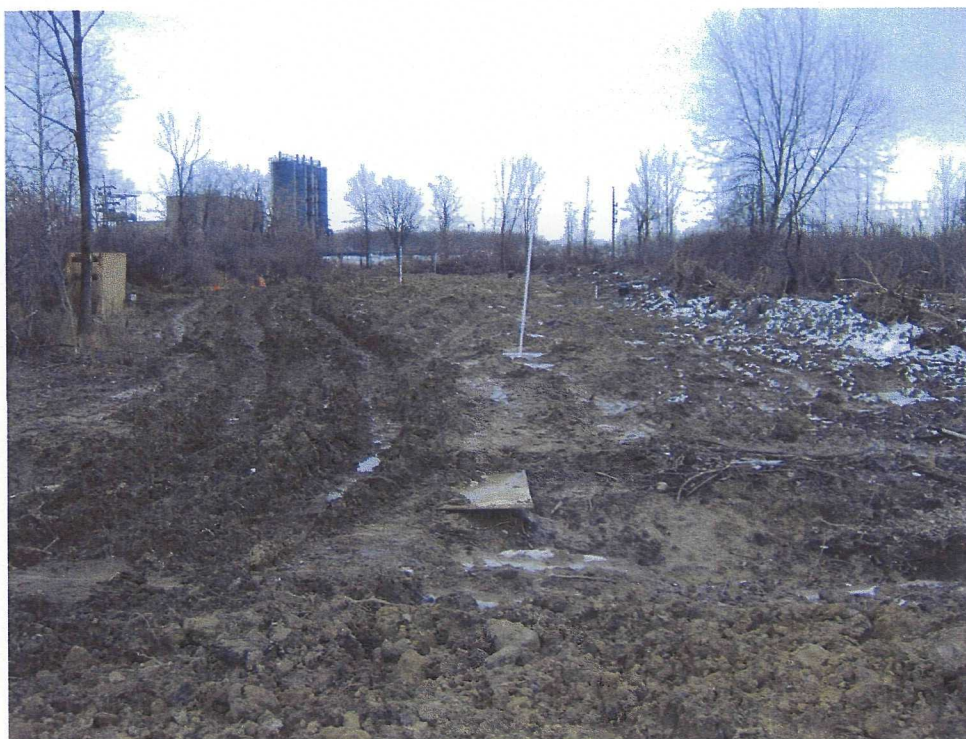
PHOTOGRAPH 13: Completed section of GWIT collection system east of GWIT Sump #2. Snow melted and sample wells are visible.

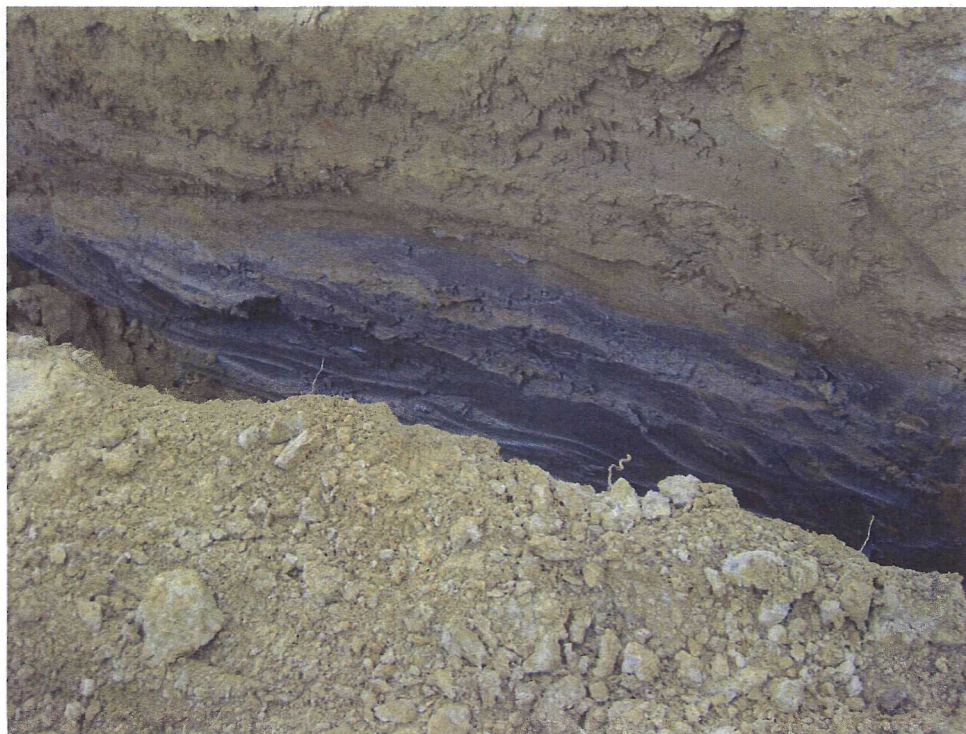
PHOTOGRAPH 14: Gray glacial till is visible west of GWIT Sump #2 where GWIT collection pipe is being installed.

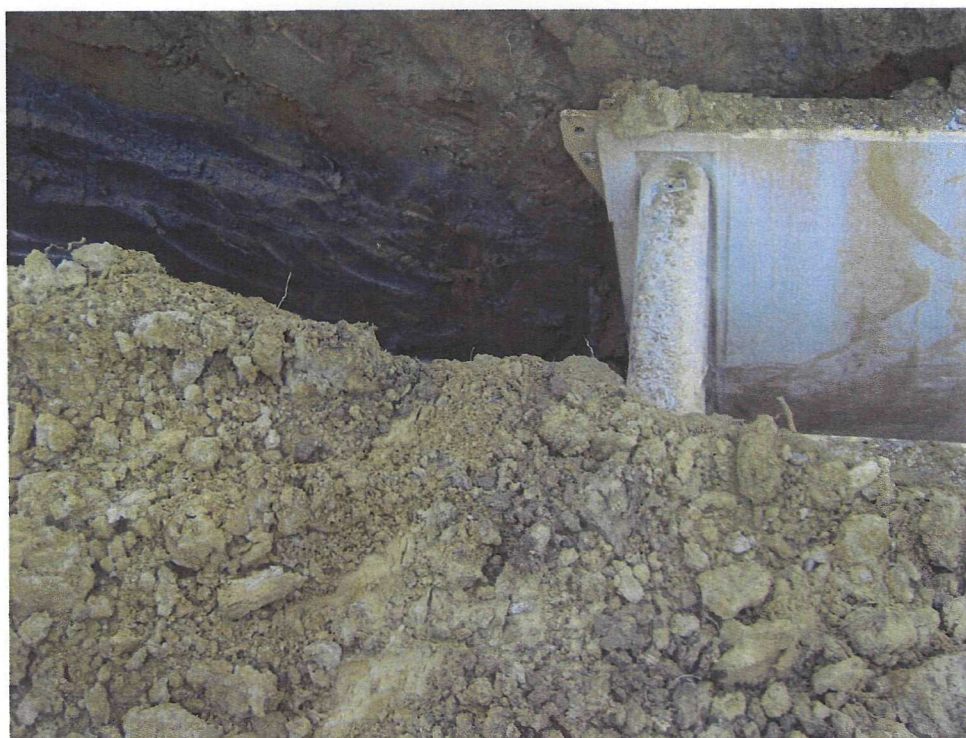
PHOTOGRAPH 15: Gray glacial till is visible below the trench box as GWIT collection pipe is being installed.

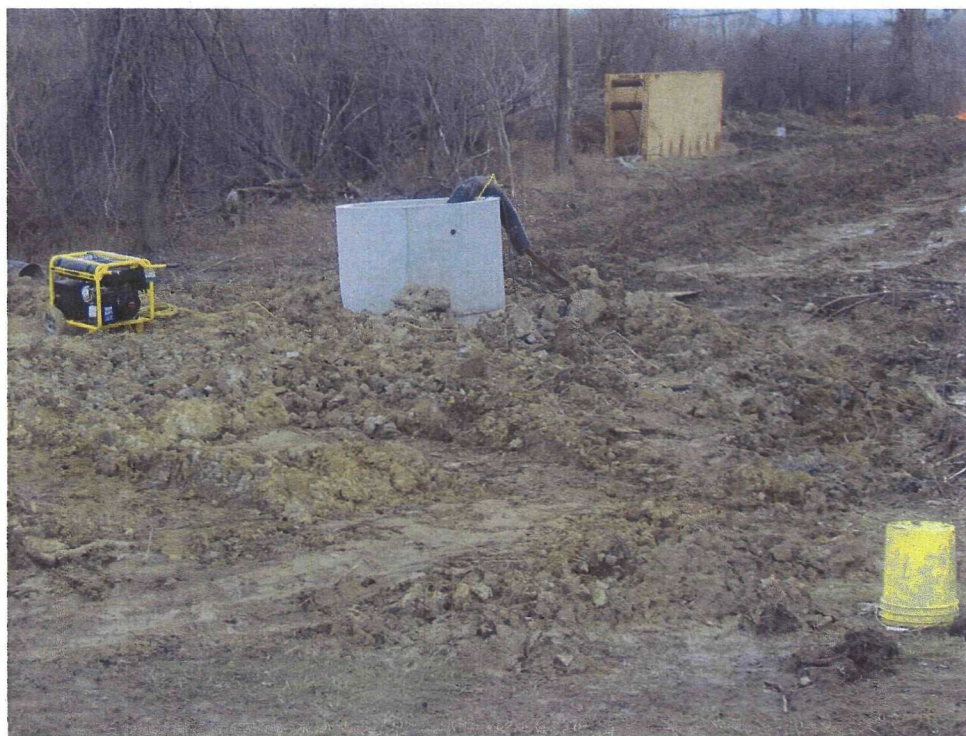
PHOTOGRAPH 16: GWIT Sump #2 after backfilling. GWIT Sump pump is used to pump GWIT collection water to the Waste Water Treatment collection GWIT Sump to the south.

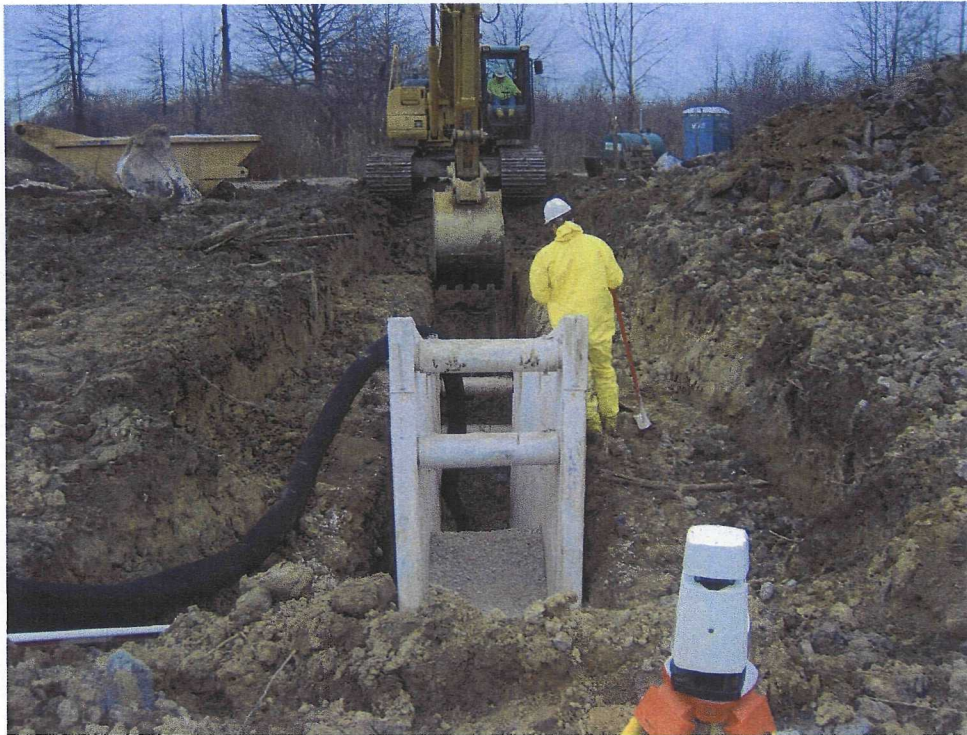
PHOTOGRAPH 17: West of GWIT Sump #2. GWIT collection system is being placed on a 5% grade using a laser level.

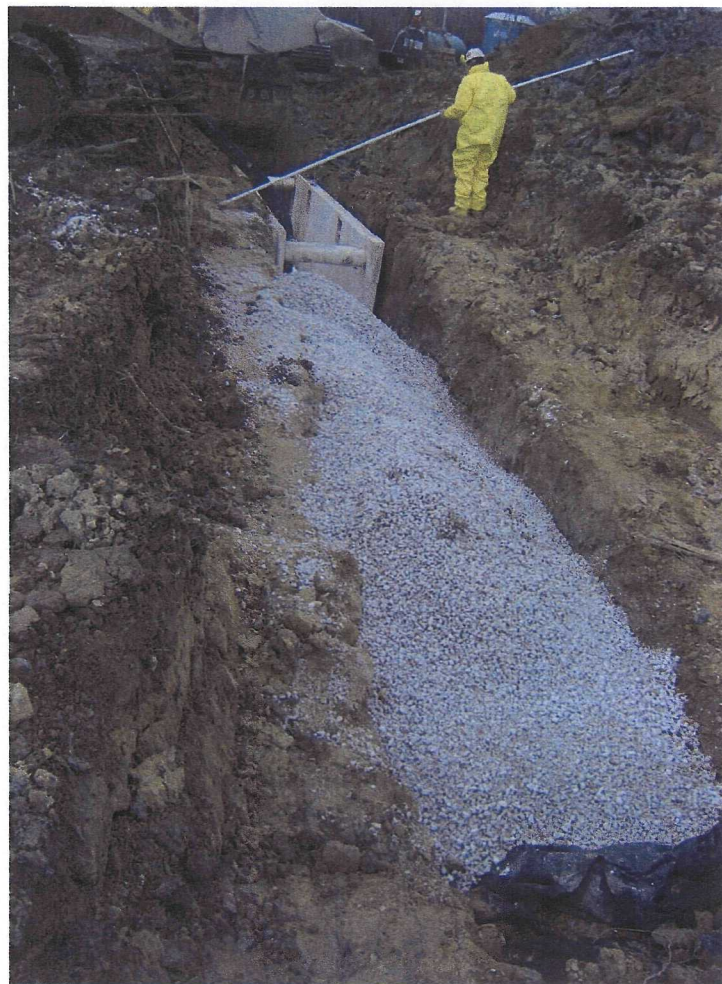
PHOTOGRAPH 18: West of GWIT Sump #2. Gravel is used to backfill the trench above the GWIT pipe to within 4' of surface grade.

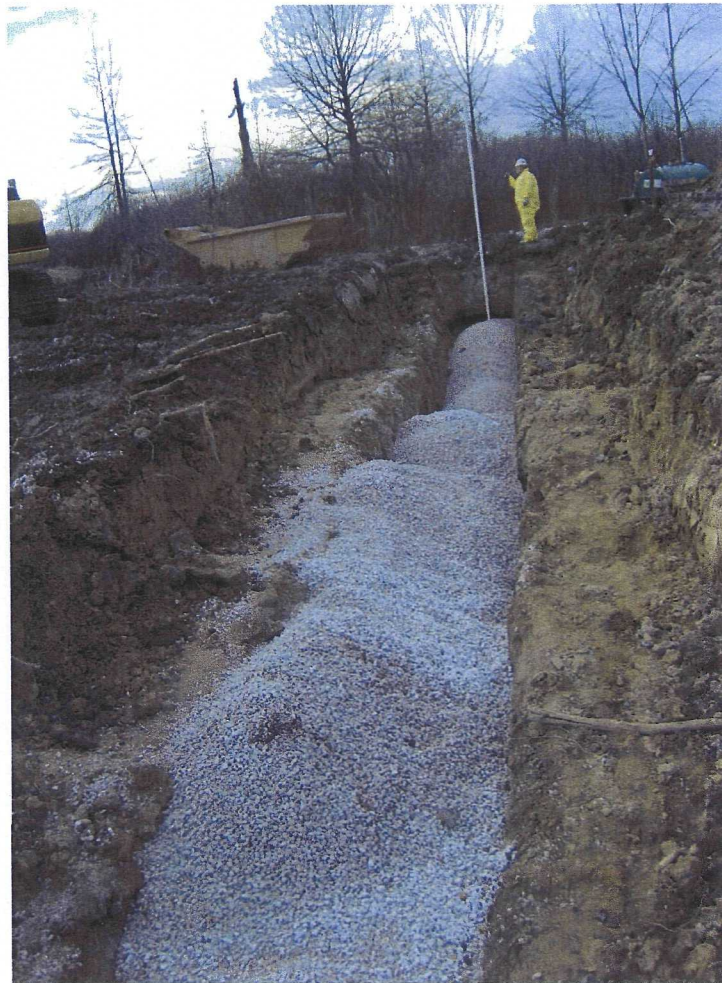
PHOTOGRAPH 19: West of GWIT Sump #2. A sample well is placed at the northwest limit of the GWIT collection system.

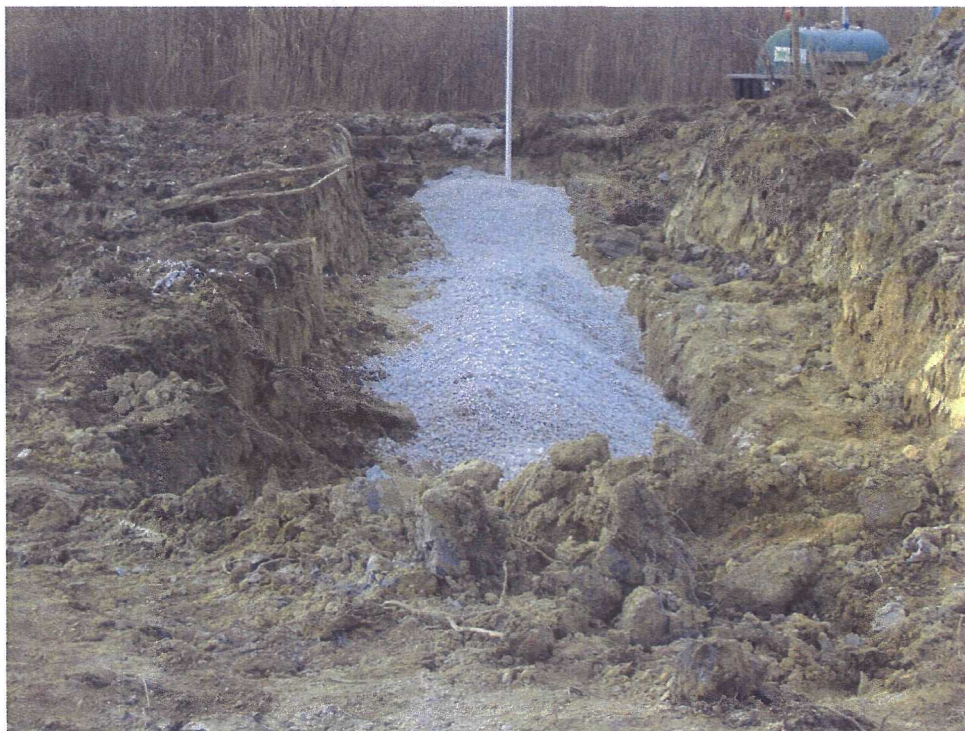
PHOTOGRAPH 20: West of GWIT Sump #2. Final section of the GWIT collection system is backfilled with gravel to within 4' of surface grade.

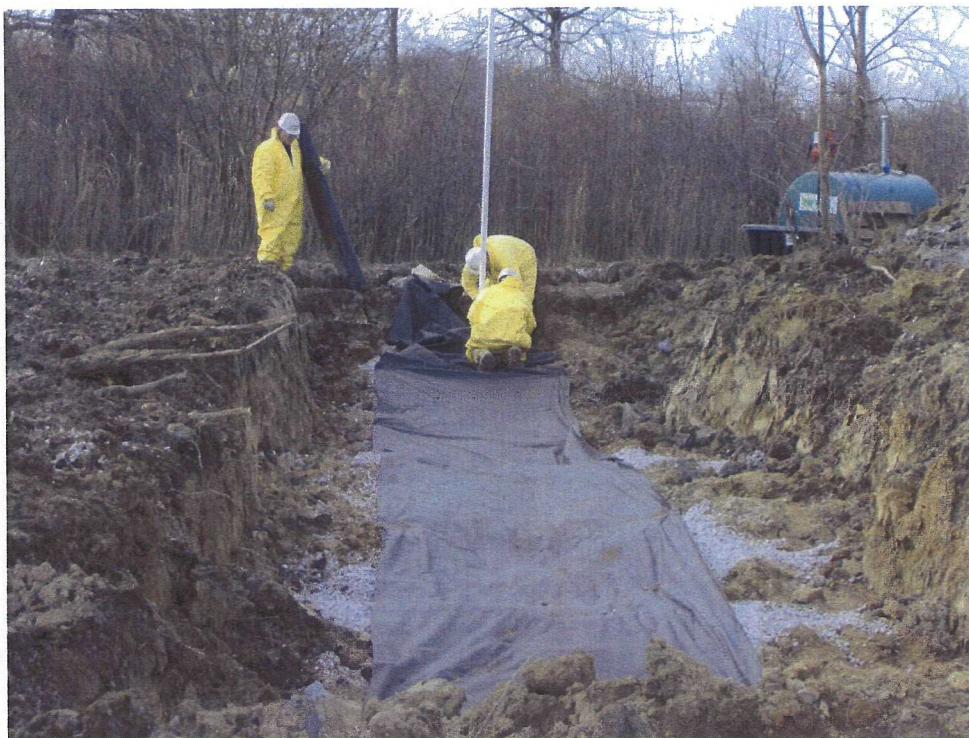
PHOTOGRAPH 21: West of GWIT Sump #2. Filter fabric is cut and placed around the sample well.

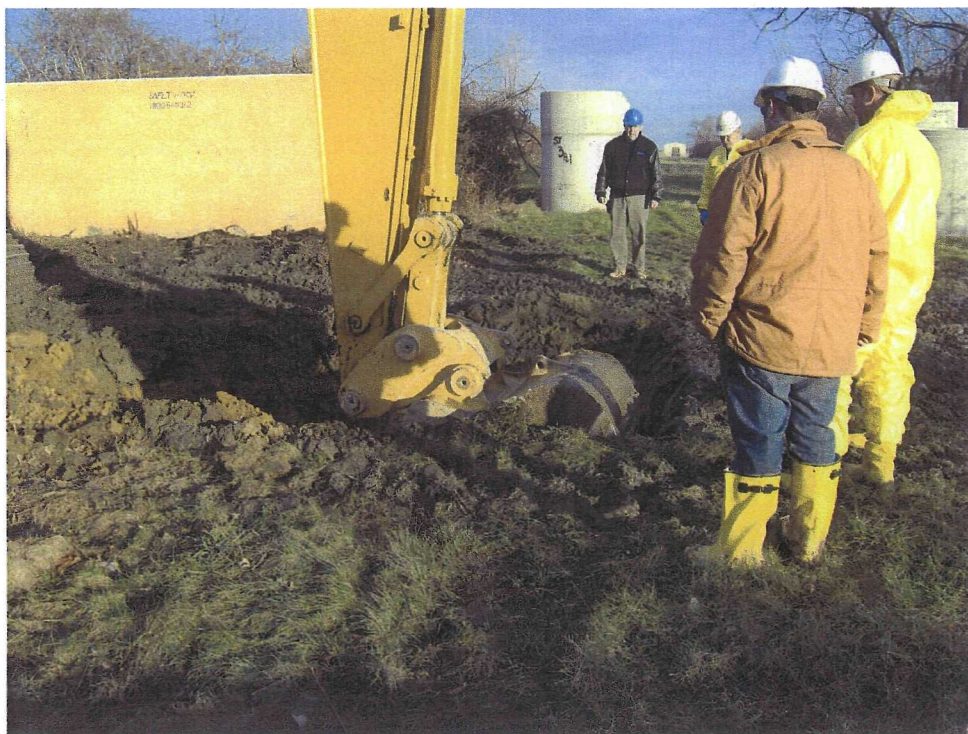
PHOTOGRAPH 22: GWIT Sump #3 placement is determined and excavation is started.

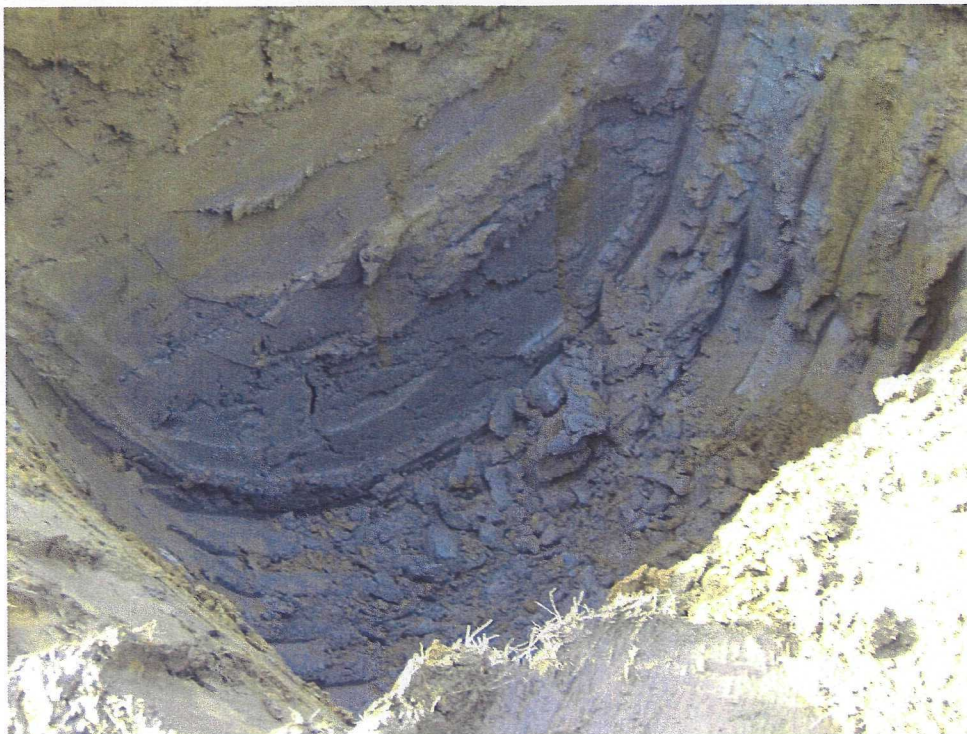
PHOTOGRAPH 23: GWIT Sump #3 excavation. GWIT Sump #3 is placed within the gray glacial till layer.

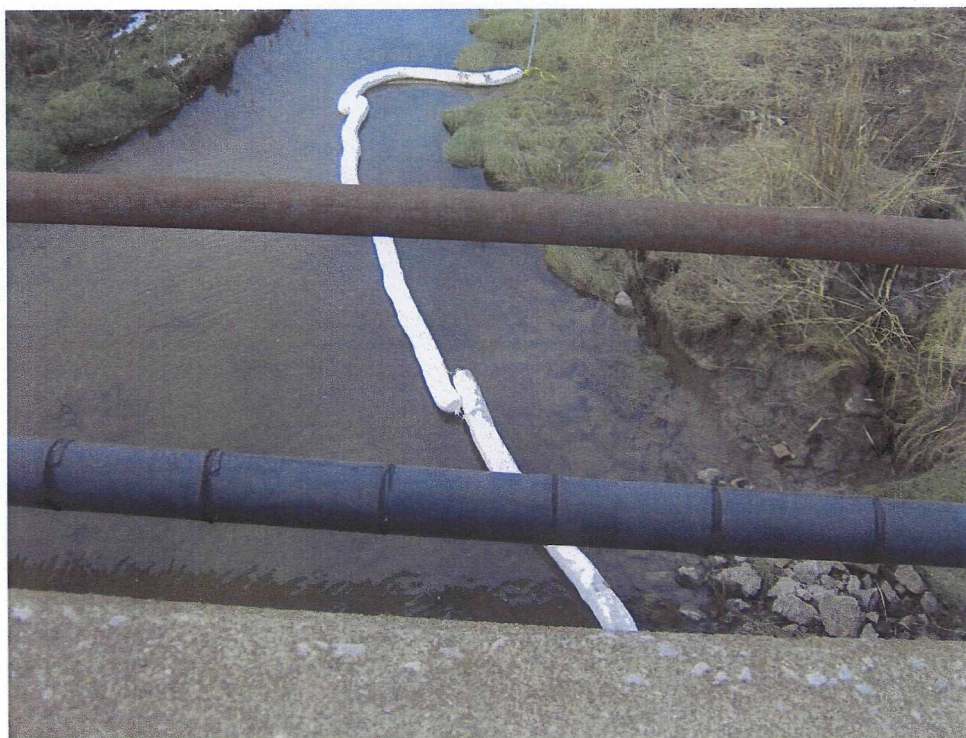
PHOTOGRAPH 25: Boom is placed in Fields Brook creek to collect sheen that could be released south of the 42" sewer pipe.

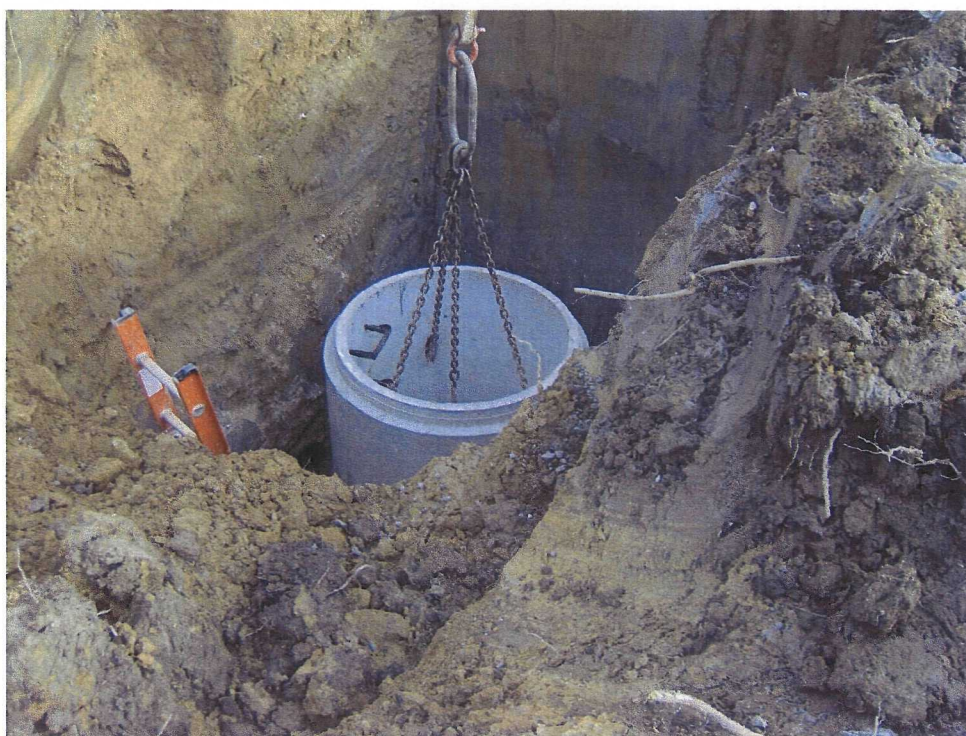
PHOTOGRAPH 26: The base of GWIT Sump #3 is placed and leveled.

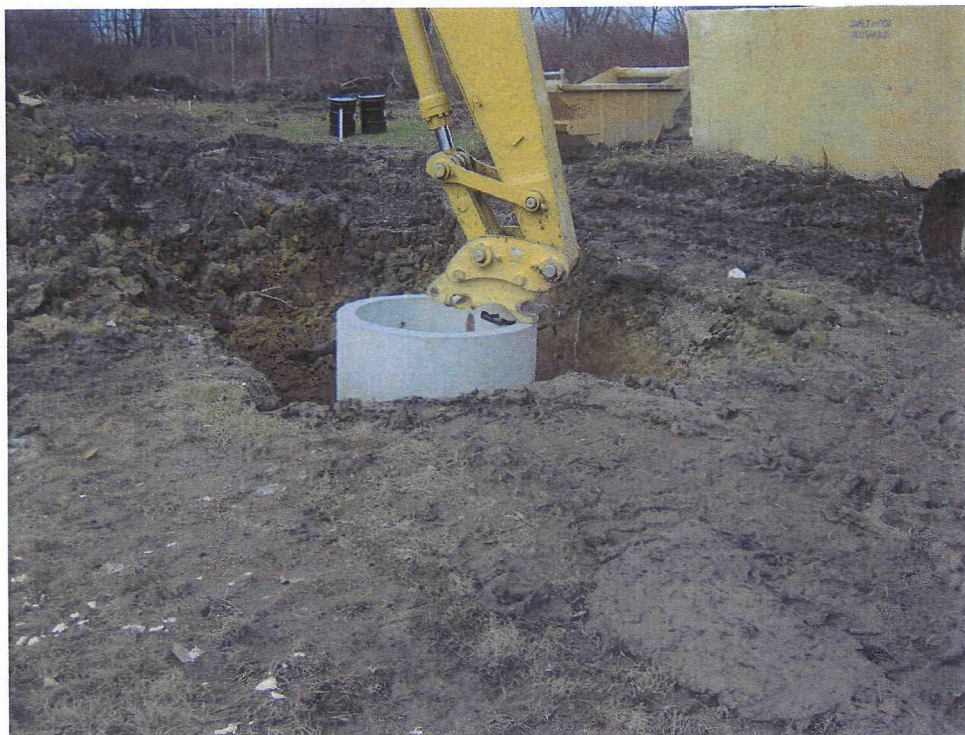
PHOTOGRAPH 27: The fourth section of GWIT Sump #3 is oriented the placed on top of third section.

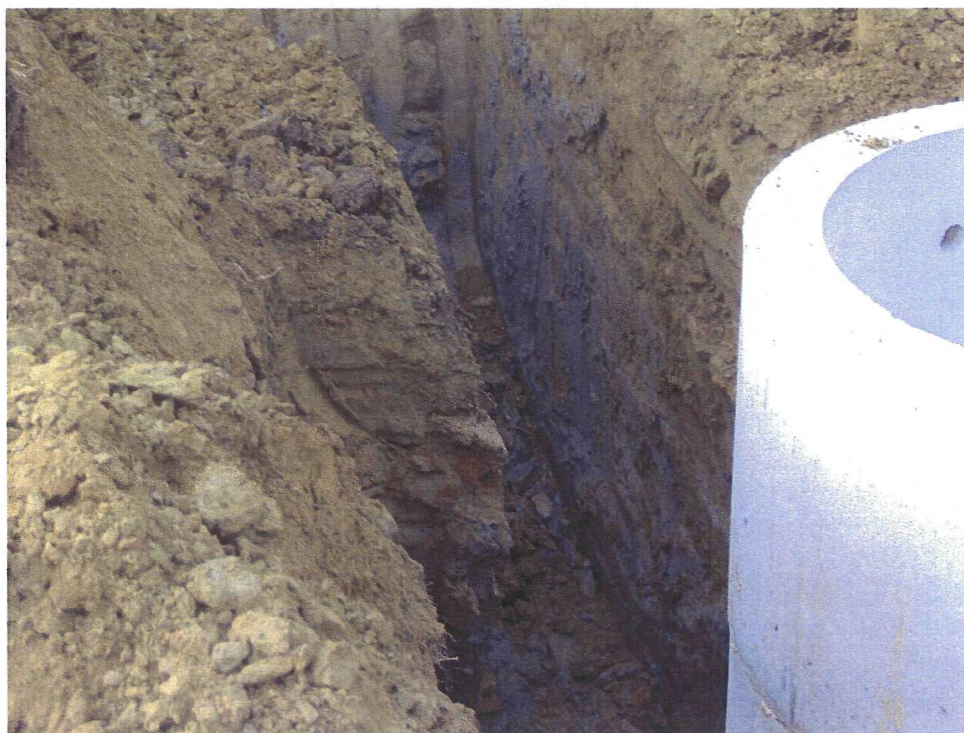
PHOTOGRAPH 28: GWIT Sump #3 excavation to the west showing placement of GWIT Sump and GWIT collection pipe in the gray glacial till layer.

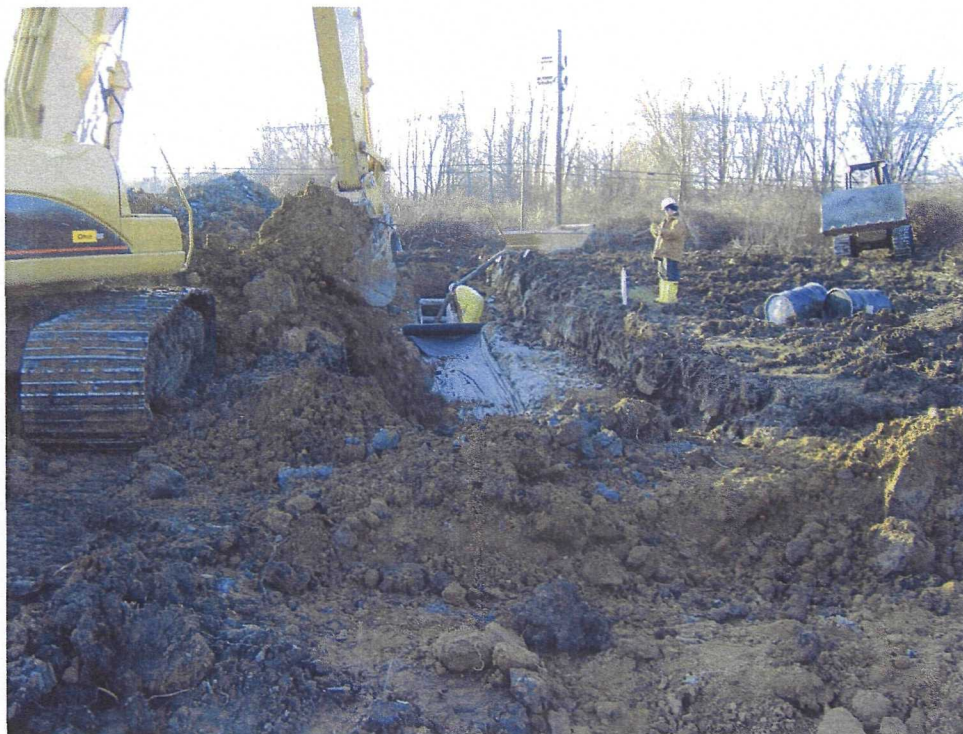
PHOTOGRAPH 29: Backfilling of the GWIT collection system west of GWIT Sump #3. Installation of this section is almost complete to State Road.

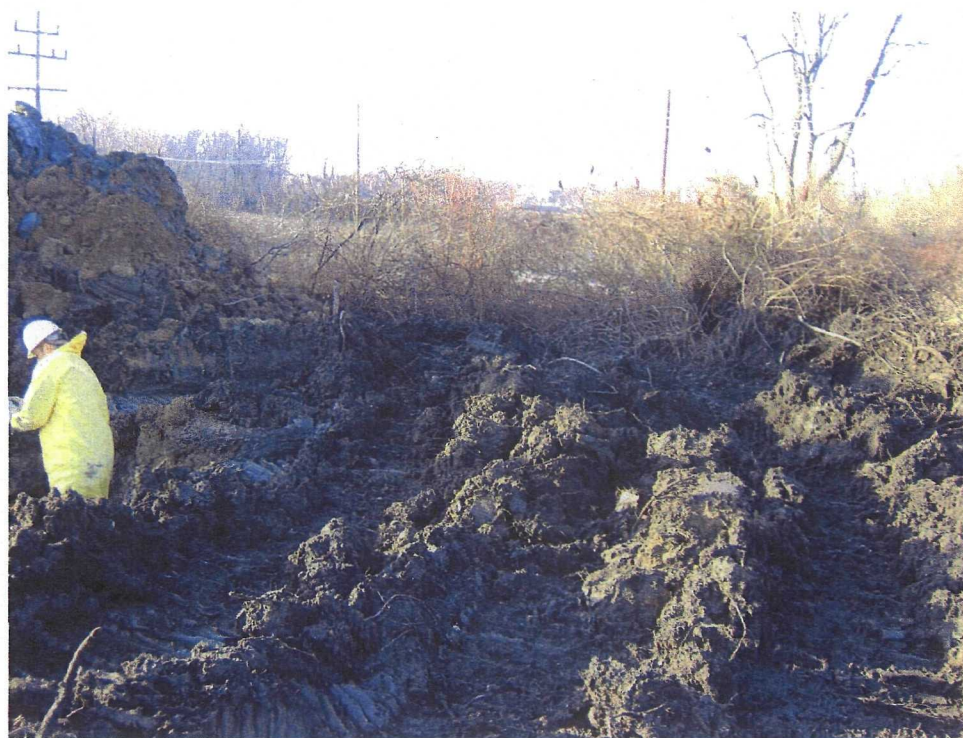
PHOTOGRAPH 30: Extremely muddy conditions encountered during the installation of the GWIT collection system west of GWIT Sump #3.

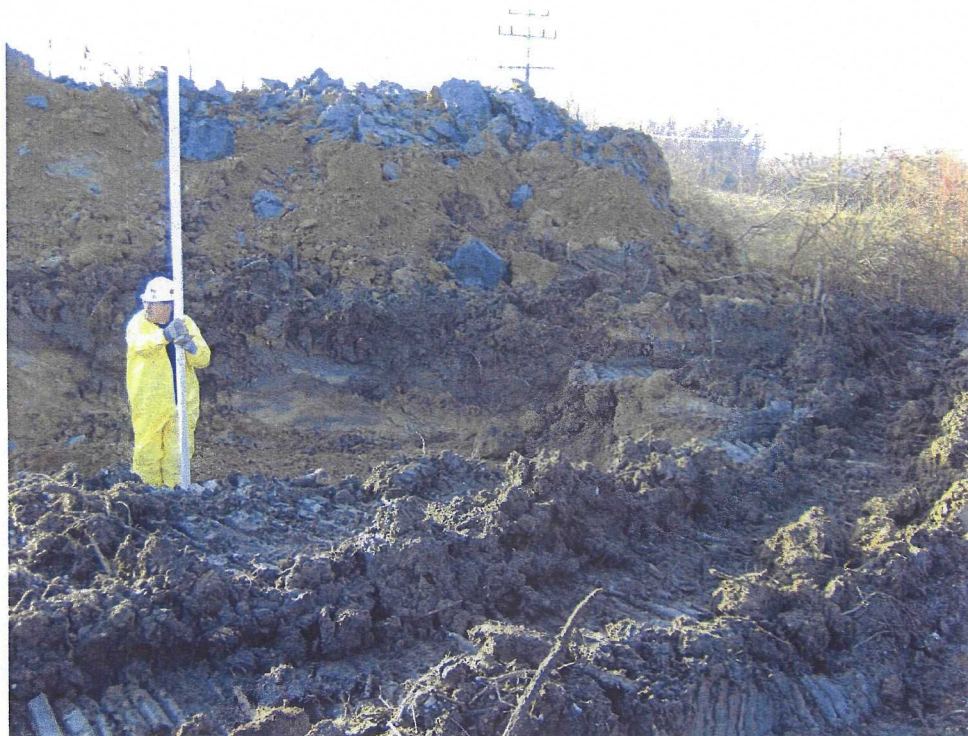
PHOTOGRAPH 31: Extremely muddy conditions encountered during the installation of the GWIT collection system west of GWIT Sump #3.

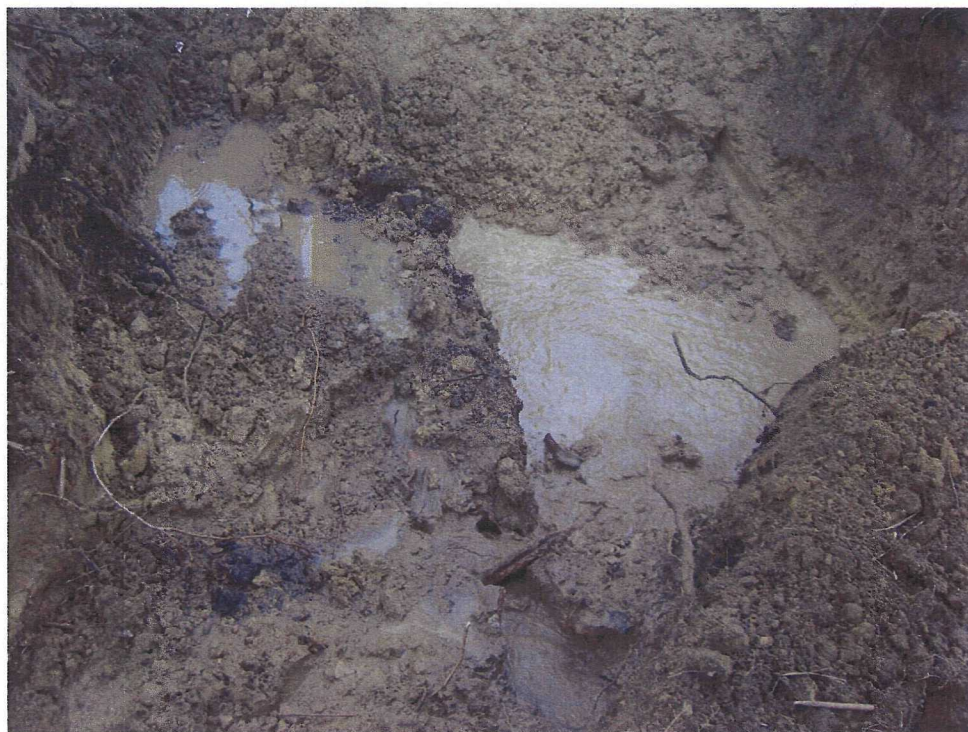
PHOTOGRAPH 32: Clay terracotta drainage pipe released water when damaged during the excavated of GWIT Sump #1.

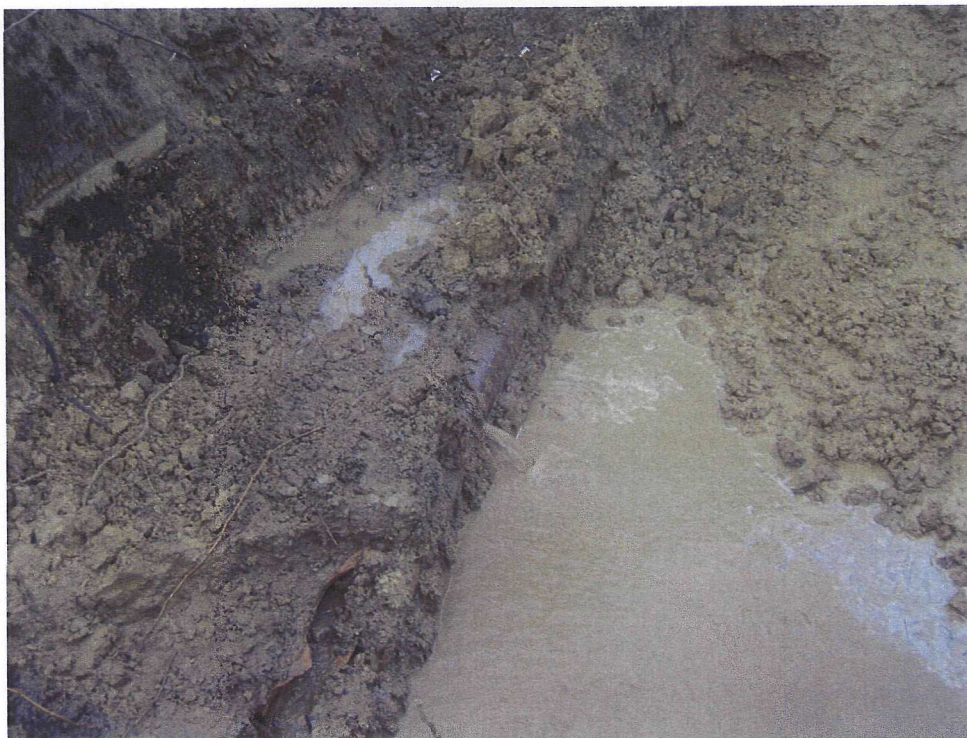
PHOTOGRAPH 33: Water released from the clay terracotta pipe continued to accumulate in the excavated GWIT Sump hole.

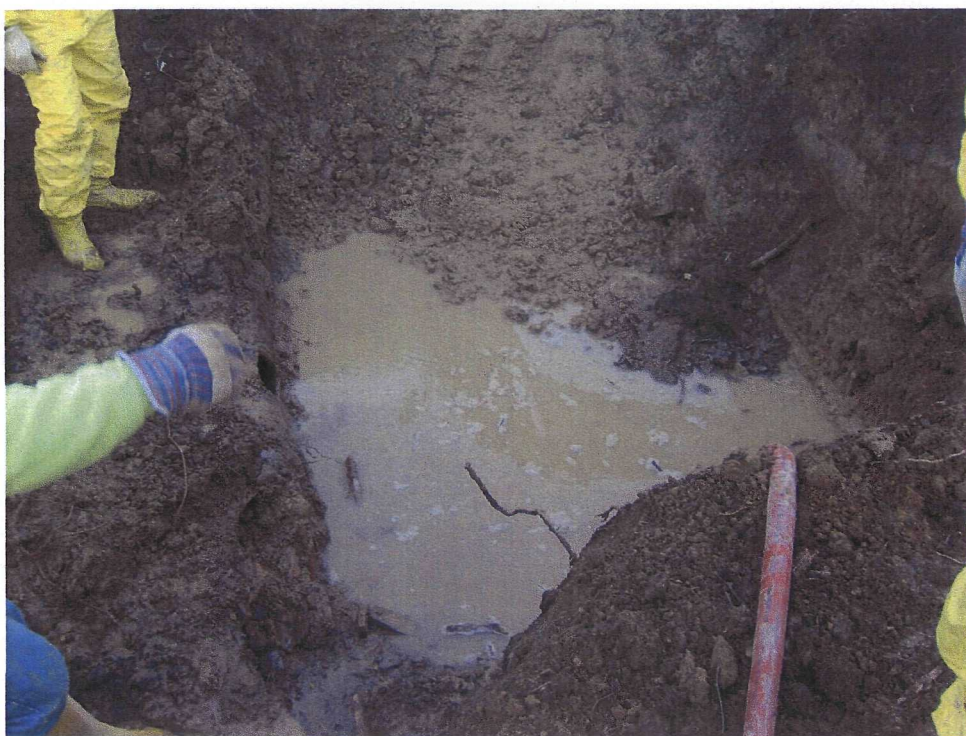
PHOTOGRAPH 34: Surface water released from the clay terracotta pipe was pumped from the GWIT Sump hole.
